# Manhole Inspection Summary

## Manhole # S11MM1012MH

Insp Date: **6/1/07 10:56 AM**

**Location** Address: **3101 VIRGINIA AVE**

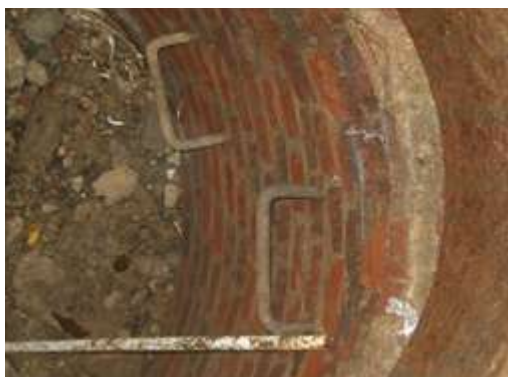
Defect 5

CORRODED STEPS

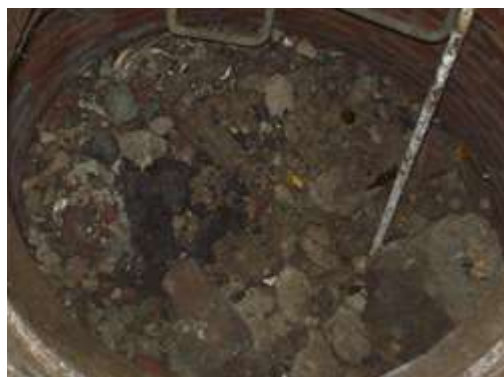
Defect 6

Condition: ☐ Sound ☐ Cracked ☐ Root Intrusion ☐ Deteriorated ☐ Leaks ☒ **Debris**

DEBRIS IN CHANNEL

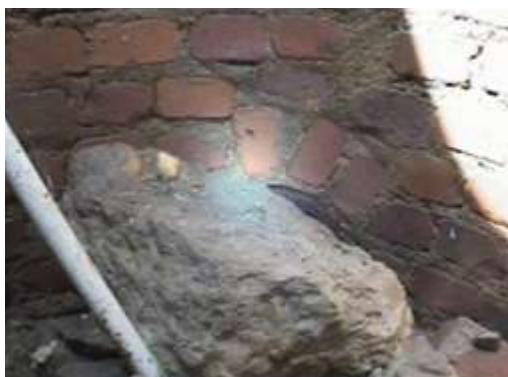
Defect 1

BIG ROCK IN CHANNEL

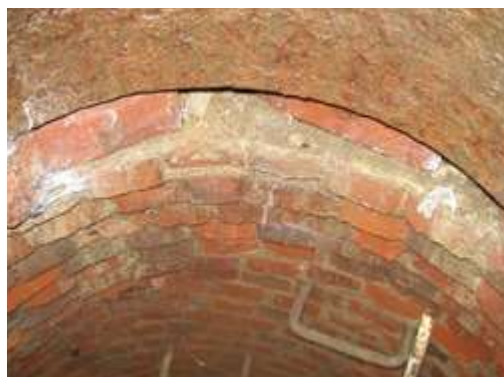
Defect 3

Condition: ☐ Sound ☐ Cracked ☐ Root Intrusion ☒ **Loose Brick** ☒ **Deteriorated**

LOOSE BRICKS IN CORBEL

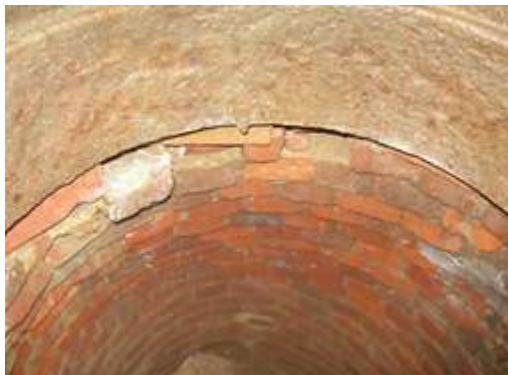
## Defect 2

DETERIORATED CORBEL

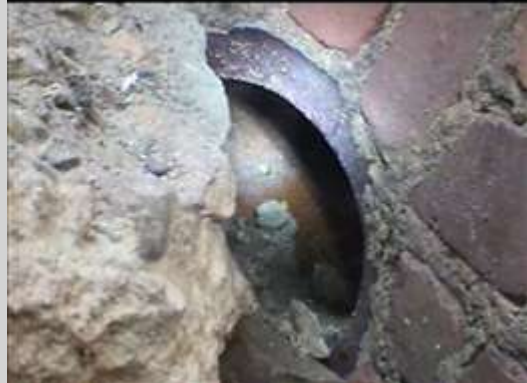
12 O'Clock Outflow

8 in. Circular Gravity Sewer  
Pipe Out @ 12 O'Clock

Deposits: ☐ None ☐ Mud ☐ Sludge ☒ **Debris** ☐ Grease

Silt Depth: **1** (in.) Deposits Extent: **Light**
